ESTABLISHING PROVEN DESIGN CRITERIA
FOR CRYOGENIC BOOST TANKS

QUARTERLY PROGRESS REPORT
PERIOD ENDING 31 JANUARY, 1962

BEECHCRAFT RESEARCH AND DEVELOPMENT, INC.
BOULDER, COLORADO

BEECHCRAFT ENGINEERING REPORT NO. 13531

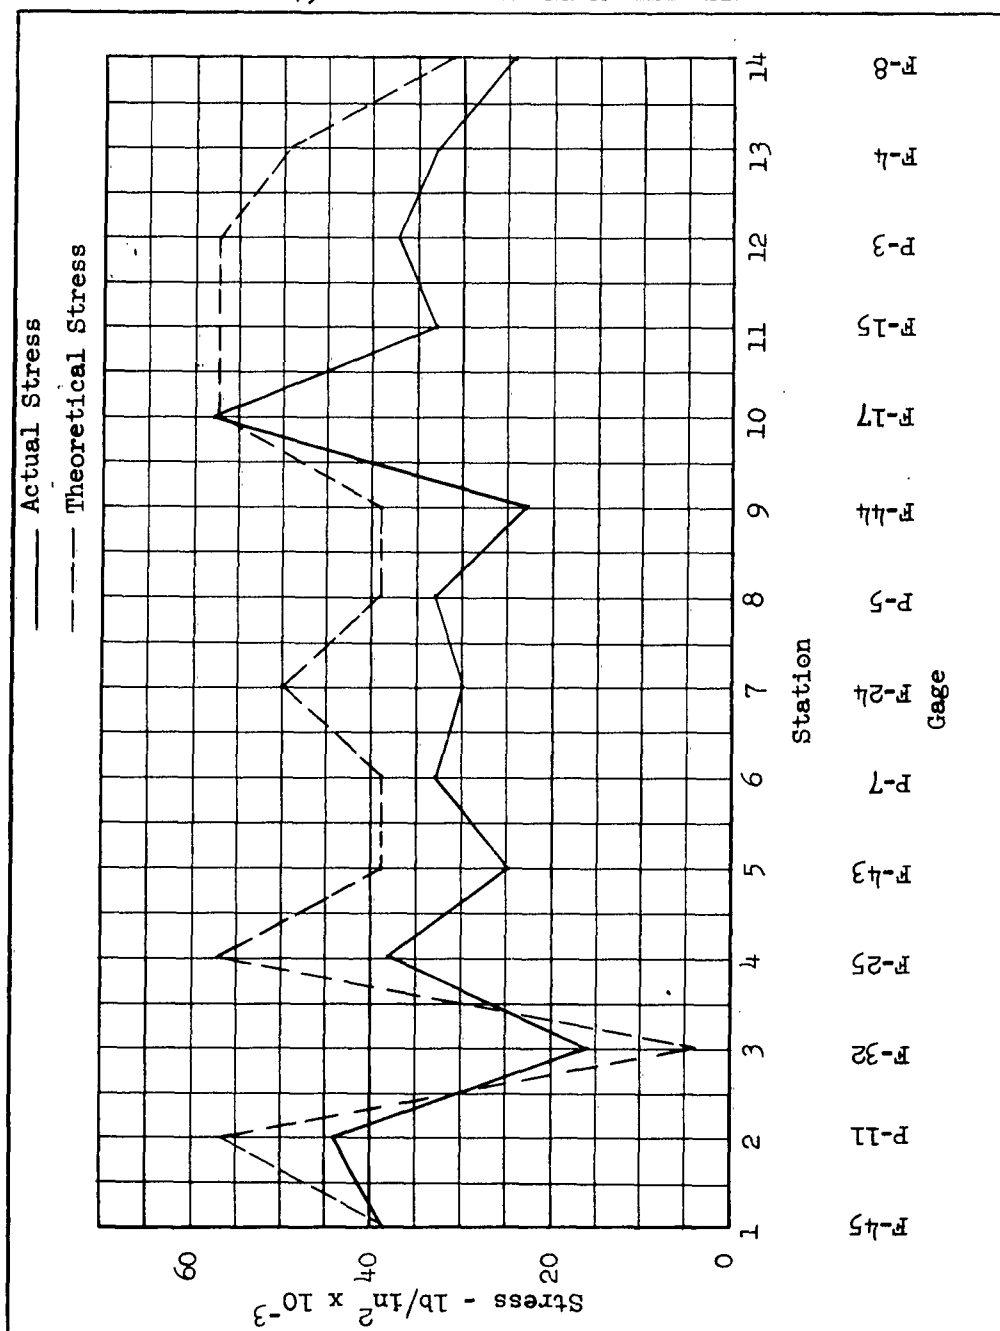
FIGURE 11
MERIDIONAL STRESS
7,000 GALLON TITANIUM TEST TANK

Figures 11 and 12 are curves showing the actual and theoretical stresses at various points on the tank. The tank is divided into 14 stations to aid in locating the area of stresses discussed. Station 1 is located at the manhole cover plate of the forward head.

In comparing actual and theoretical stresses, it is seen that in almost every case the actual stresses are less than those predicted by theory. This is largely a result of the fact that a conservative analysis was made in determining the theoretical stresses. In areas of pure membrane stress the minimum skin gage was chosen in computing stresses. The worst possible conditions were chosen at discontinuities. Since these conditions did not exist in the test tank, the measured stresses normally were less than the theoretical values.

In general, the actual stresses were less than the theoretical stresses. Figures 11 and 12 show that the two stresses followed the same trend. The major exception to this rule occurs at the foam-filled areas where the actual stresses were higher than the theoretical.

The data indicate that the stress concentrations at discontinuities are not as serious as would be expected from a theoretical analysis.
